Water Crossing 1 – Tributary to Sheldrake Lake

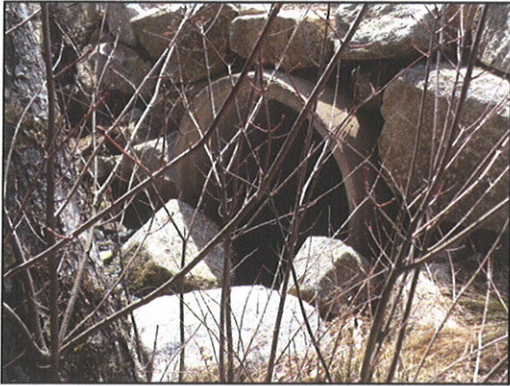
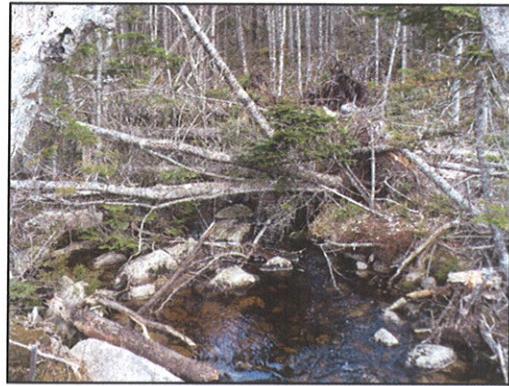
At Highway 103 there is an existing 1800 mm diameter concrete culvert. This culvert will require an extension to accommodate the construction of a ramp from the proposed Highway 113. The existing culvert is in excellent shape and the ordinary high water mark appears to be only a little over half way up the culvert. The stream in the vicinity of the extension is approximately 10 m wide immediately upstream of the culvert. Large boulders are present at the inlet of the culvert, preceded by a pool and a defined channel. The predominant particle size upstream is boulder and the depth ranges from 25 mm in the riffles to greater than half a metre in the pool. The water shed is well vegetated with mixed forest.

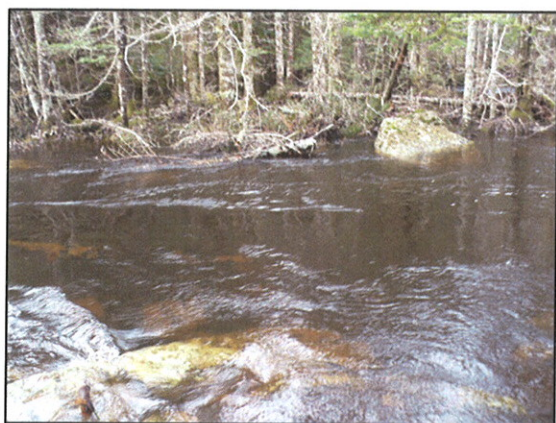
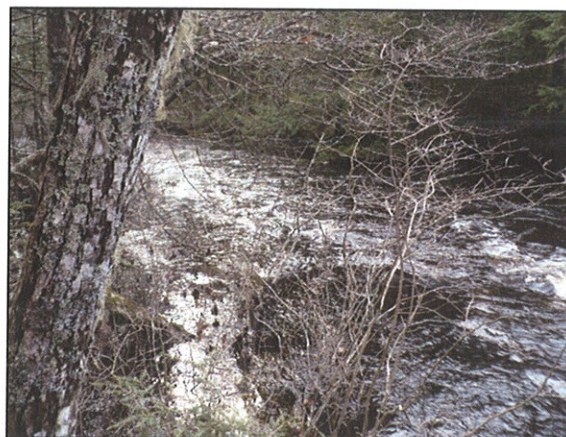
Channel at the proposed highway

The watercourse is greater than 20 m wide at the approximate location of the highway crossing. The water had over topped the banks and was flooding the adjacent forested area. The water depth could not be estimated due to the width, darkness and depth of water in the stream. The visible stream bed was made up of predominantly boulder sized particles. There were no apparent pool/riffles along the watercourse.

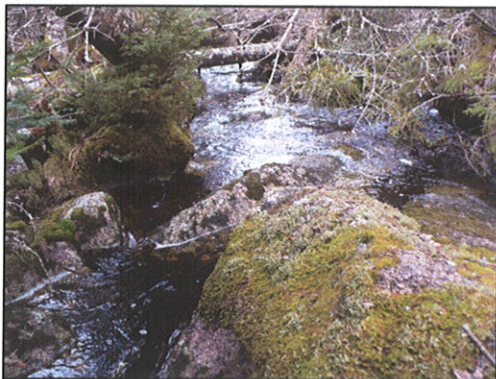
Crossing 3A

Fishers Brook at 3A flows from the north at the proposed crossing of the 113. The channel width at 3A ranges up to 10 m and the channel bottom is comprised of mostly boulder sized rocks, with gravel and sand in pooled areas.

The terrain is moderate to steep with treed and vegetated banks. There are several fallen trees over the stream providing cover and several pool/riffle/run arrangements. The channel bank material and channel alignment north of the crossings do not indicate meander potential.

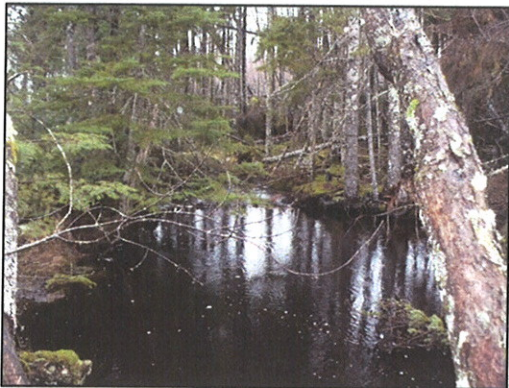
Crossing 3B

Fishers Brook flows from the northeast as it crosses the proposed Highway 113 at 3B. The channel width at 3B is greater than 15 m and is essentially ponded in the area of the proposed crossing. There is a defined channel downstream. The character of the stream at the crossing is affected by the large wetland at the downstream end. The channel is approximately 1 m deep and very dark. The stable particle size was not visible during the field visit. The channel and the terrain are very flat. AS depicted in the adjacent photo,

the stream banks are vegetated with trees. Similar to the watershed for Crossing 3A2, the watershed includes areas of re- growth from a historic fire in the area.

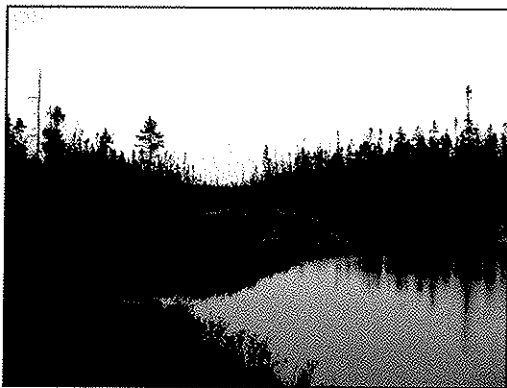
Crossing 3C is a ponded area, approximately 15 m wide, bordered by wetland. Although the observed flow was very low, the apparent flow from mapping is from the north across

the proposed 113. The channel bottom was not visible during the field visit and therefore depth and stable particle size were not ascertained.

The watershed in the immediate vicinity of the proposed crossing is marshy and grassed. A strip of trees outlines the marshy area. The terrain is fairly flat.

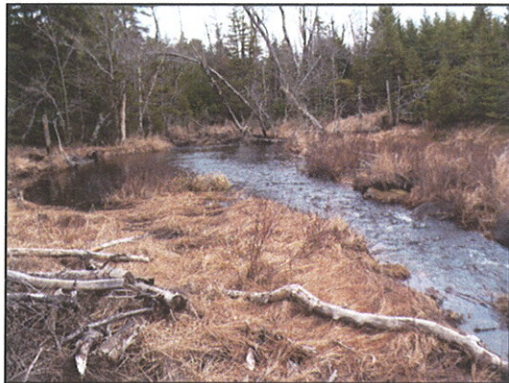
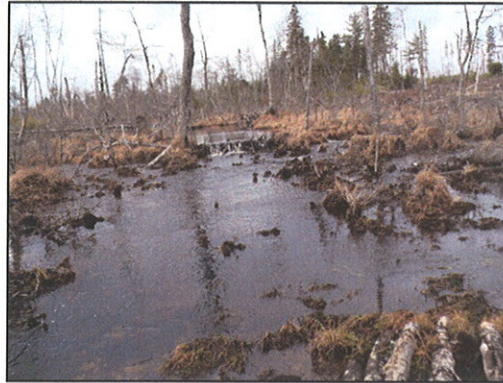
Channel at the proposed highway

The watercourse width varies in the area of the proposed crossing from about 1 m wide as depicted in the adjacent photo where the stream is defined to greater that 20 m wide in a flooded area as evident in the photo below. The area in the vicinity of the watercourse was clear cut and the topography is generally flat. The water depth was approximately 1 m deep in the defined channel. The stable particle was cobble/boulder. There were apparent pool/riffle/runs along the watercourse.

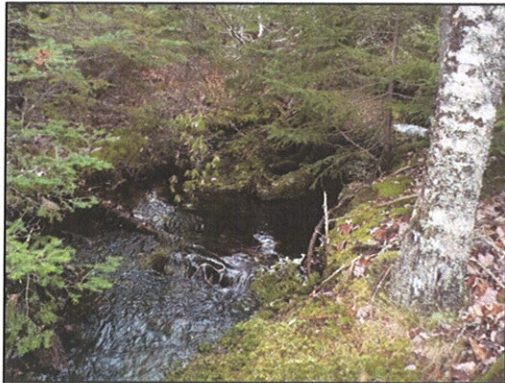
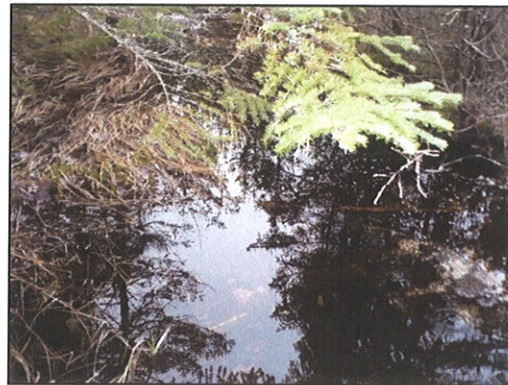
Crossing at 5

The watercourse at crossing 5 flows from the north across the proposed alignment for Highway 113. At the approximate crossing location, the channel varies from 1 m wide at the defined channel to 10 m wide at a pool. Beyond the pool on the downstream side, there is a wetland. The water depth ranges from a few centimetres in the riffle to > 1m in the pool. The stable particle varies from boulder sized in the channel to gravel sized in the pool. The slope of the channel is fairly flat and the terrain varies from shallow to the west of the stream and steep on the east. The watershed is mainly treed in the vicinity of the crossing.

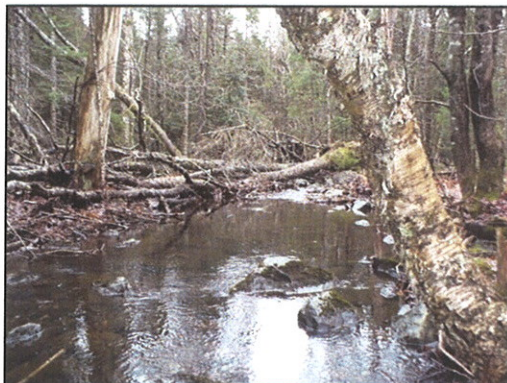
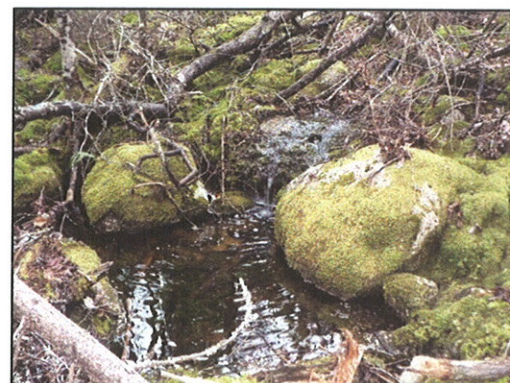
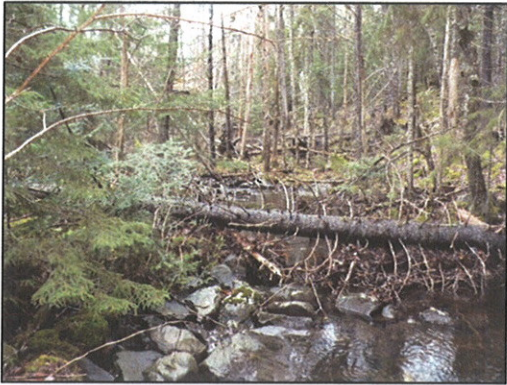
Crossing at 5A

The tributary to the outlet of Ragged Lake flows from the southeast across the proposed Highway 113 where it joins the Outlet of Ragged Lake. The channel varies from less than 1 m wide at the defined channel to 1.5 m wide in the pool. Similar to crossing 5, the tributary to the outlet of Ragged Lake flows into a wetland on the downstream side. The water depth ranges from a few centimetres in the riffle to about 30 cm in the pool. The stable particle varies from boulder sized in the channel to gravel sized in the pool. The slope of the channel is fairly steep. The terrain is vegetated with trees and fairly steep on both banks of the stream.

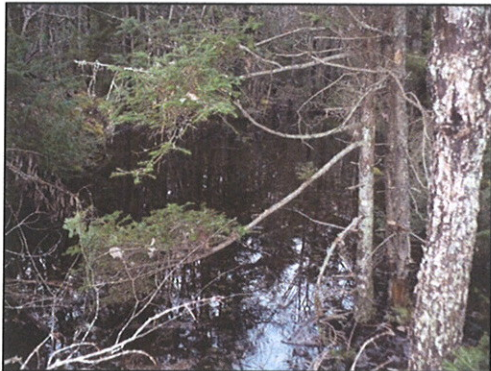
Channel at the proposed highway

The watercourse width varies in the area of the proposed crossing from about 2 m wide in the runs and up to 10m wide in the pools. The area in the vicinity of the watercourse is treed and the banks of the channel are steep. As the photographs indicate, several trees have fallen over the channel. The water depth ranges from 20 cm to 30 cm. The stable particle is cobble/boulder. There were apparent pool/riffle/runs along the watercourse.

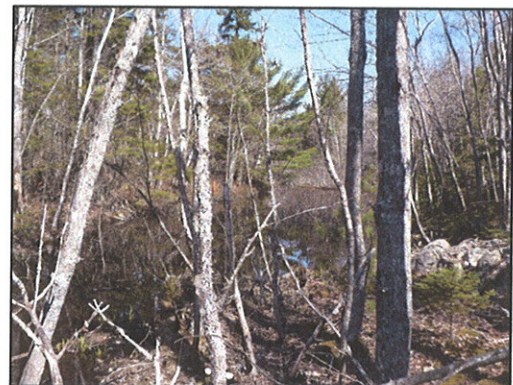
A drainage course was observed during field work within the watershed of Black Duck Brook. It is believed to be a seasonal drainage area. It is depicted in the above-right photograph.

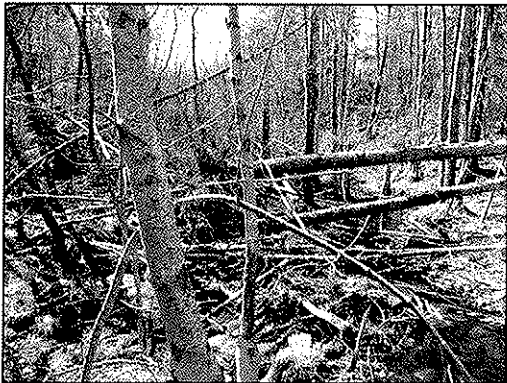
Channel at the proposed highway

Upstream of the approximate crossing location is a ponded area that is approximately 40 m long and 20 m wide. The watercourse width in the area of the proposed crossing is about 2 m wide. The area in the vicinity of the watercourse is treed and the banks on the south east side of the channel are steep and the northwest side are moderate. As the photograph to the left indicates, several trees have fallen over the channel. The water depth ranges from 2 cm to 20 cm. The stable particle is cobble/boulder. There were apparent pool/riffle/runs along the watercourse.

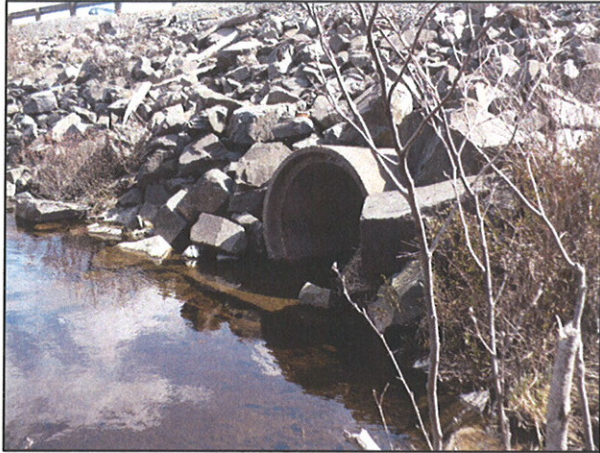
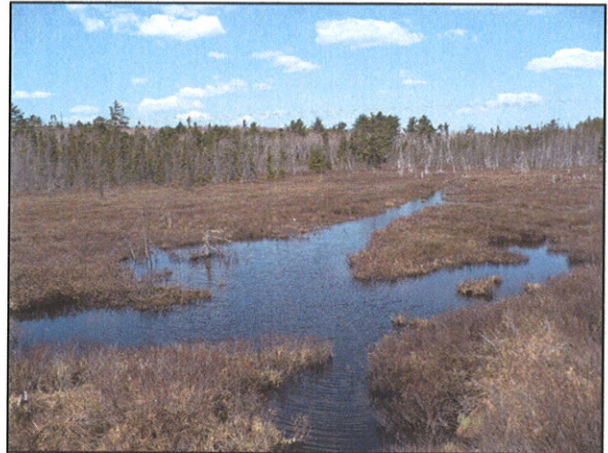
Upstream of the crossing is a large wetland as depicted in the attached photo. The channel currently flows under the existing Highway 102 through a 900 mm diameter concrete culvert. Downstream of the highway the channel flows into another wetland. The existing concrete culvert is in excellent condition and the high water mark appears to be approximately half way up the culvert. There is a pool upstream of the culvert and a meandering stream through the wetland. The immediate watershed is fairly flat and is vegetated with grasses.

As discussed above, a second channel flows along Highway 102 and into the wetland that eventually flows into this watercourse. It is a very small channel that takes ditch flow from the high point on Highway 101 and discharges into water crossing 8. It is only 1 to 2 m wide and less than 0.5 m deep.
